MOTOR FAILURE REPORT			
JOB INFORMATION			
ETI Job#: 00043336  Customer: ETI  Motor Mfg: AMK Arnold Muelle  Motor Type: SKT7-28-20-T00  Serial No: D346BD-451838  Equip Mfg: Arburg	er	Rpt Date: PO: Ref.: Cust Job #: Consignee PO: Equip Type: Equip SN:	Friday, July 3, 2020 CC CN 420A 195965
INSPECTION / TEST			
External Damage  Yes  No			
Parts Missing Yes V No			
Test Run Yes No			
Test Duration Dri	rive Used n/a		
Amplifier Alarms Cust. overcurrent ETI n/a			
COMPONENT CONDITION			
Stator Pass	Fail		
Rotor Pass	Fail Magnets loose a	nd slipping	
A side bearing journal  Pass	Fail		
B side bearing journal  Pass	Fail		
A side bearing bore  Pass	<b>F</b> ail		
B side bearing bore  Pass	<b>F</b> ail		
Output shaft	<b>Fail</b>		
Mounting flange	Fail		
Power connector Pass	Fail		
Encoder connector Pass	Fail		
Encoder Pass	Fail		
Bearing condition Pass	<b>✓</b> Fail		
CAUSE OF FAILURE			
✓ Contaminated	End of Life	Belt overtension	Alignment/Mechanical fit

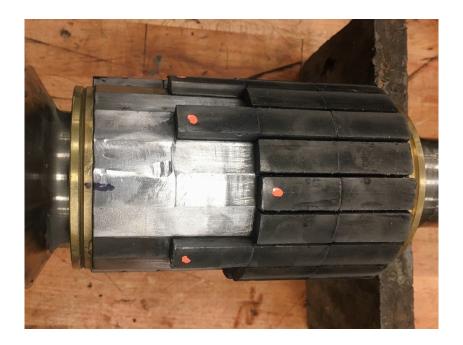
- 1. The primary cause of failure was a completely worn out encoder drive belt.
- 2. A secondary cause of failure was loose and slipping magnets on the magnet rotor.
- 3. The stator was badly contaminated with some kind of oil, but it had not caused any electrical failure.
